## TECHNICAL NOTE

# Are super-long escalators safe? Lessons learned from the Langham Place escalator incident in Hong Kong

A H W Ngan and K W Siu

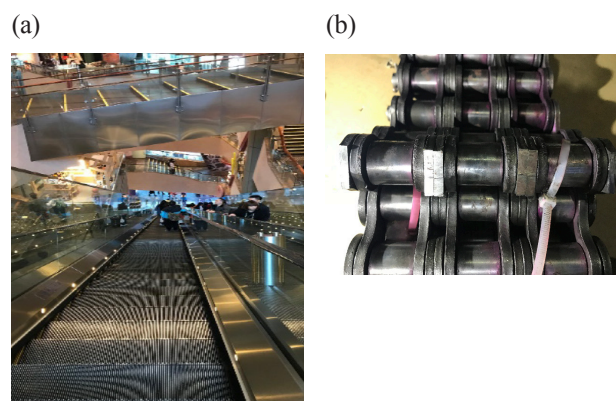
An incident involving an escalator with an exceptionally high elevation of 21 m (Figure 1(a)) happened in Hong Kong's Langham Place on 25 March 2017 (The Straits Times, 2017). Investigation (Electrical and Mechanical Services Department, 2017) revealed that the incident was due to the snapping of the main drive chain (Figure 1(b)) that supplied power from the driving motor to the movable steps (Figure 2(a)), and the malfunctioning of a “broken chain safety device” which was supposed to be a foolproof device for braking the movable steps in case the main drive chain snaps. As the main drive chain suddenly snapped, the steps became disconnected from the drive mechanism, and the weight of the passengers caused the escalator to roll downward. The incident has caused serious injuries to a number of passengers (The Straits Times, 2017).

Figure 1. (a) The super-long escalator with a 21 m vertical elevation, involved in the Langham Place incident; and (b) a cut section of the broken main chain drive as inspected by the first author on 2 February 2018 at EMSD.

On 25 March 2017, an escalator with an elevation of 21 m running from the fourth to the eighth floor at Langham Place in Hong Kong suddenly stopped, reversed and then sped up, causing the riders to lose balance, fall and pile up at the bottom (Electrical and Mechanical Services Department, 2017; The Straits Times, 2017). Investigations carried out by the Electrical and Mechanical Services Department (EMSD) of the HKSAR Government (2017) revealed that the malfunction was caused by a faulty drive chain, and the broken chain safety device failed to work.

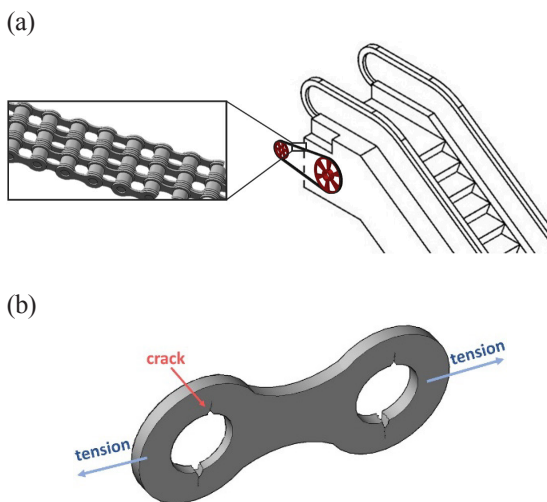
Figure 2. (a) Schematic showing the main drive chain of an escalator; and (b) locations likely for fatigue cracks to initiate in a link plate.

As shown in Figure 2(a), the main drive chain transmits power from the motor to the movable steps of the escalator. As such, the drive chain is subjected to a predesigned tension during one half of its revolution, and is relaxed during the other half. Due to this form of cyclic loading, the drive chain is prone to metal fatigue. As illustrated in Figure 2(a), the drive chain design has a linked structure comprising link plates connected by pins and bushes. As indicated in Figure 2(b), fatigue cracks are preferentially initiated on the inner side of the link plates in contact with the pins or bushes (Figure 1(a)), where stress concentration is expected to be the highest. Figure 4 shows the geometrical specifications of the ISO R606 24B-3 chain used in the drive chain design of the Langham Place incident. The stress concentration factor in a plate containing a symmetrical hole is principally determined by the aspect ratio of the plate width (H in Figure 4) to the hole diameter (D in Figure 4), and is not significantly affected by the plate thickness T1 or T2 (Pilkey, 2005).

positions in Figure 2(b), the highest stress occurs. The stress concentration factor (i.e. the ratio between the maximum and average stress) at such a location is > 3. Fatigue cracks are therefore expected to initiate at the inner positions of the link plate as indicated in Figure 2(b), and these are locations not visible to a safety inspection personnel.

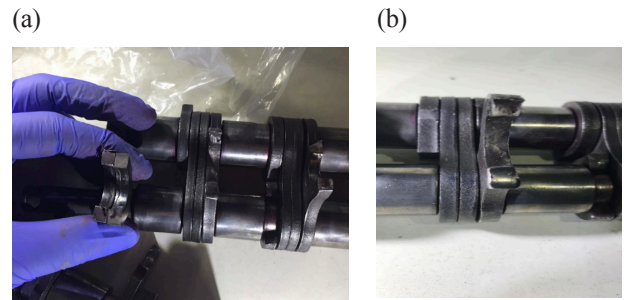
The first author of this paper served as an expert witness in this court case. The main drive chain involved in the incident (Figure 1(b)) had a linked construction as illustrated in Figure 2, and the investigations appointed by the EMSD established the cause of the drive chain failure to be the metal fatigue of the link plates. Figure 3(a) shows the link plates of the drive chain involved in the accident, broken predominantly from fatigue cracks illustrated in Figure 2(b). In Figure 3(b), signs of fatigue failure can be observed on the fractured surface of a broken link plate.

Figure 3. (a) Link plates of the drive chain involved in the Langham Place incident, broken from the cracks shown in Figure 2(b); and (b) enlarged view showing signs of fatigue failure on the fracture surface of a broken link plate. Photos taken by first author on 2 February 2018 at EMSD.

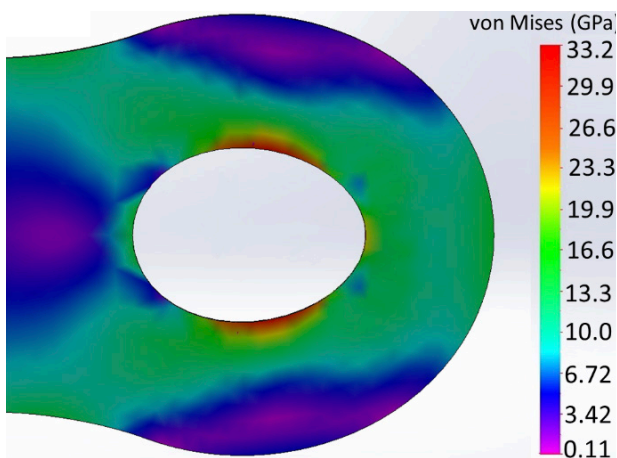
Figure 5 shows a finite-element calculation of the von Mises stress state in a link-plate shape with a similar aspect ratio of 2.26. In this finite-element simulation, the link-plate is under tension with bearing load acted on the wall of the hole. The absolute values of the von Mises stress are proportional to the applied tensile force on the plate and inversely proportional to the square of its linear dimension, but the ratio of stresses at any two locations is a sole property of the plate shape and is independent of the applied force and the absolute dimension of the plate. It can be seen that on the inner side of the pin hole, marked by the crack

Figure 5. Finite-element prediction of von Mises stress state in a link plate shape of aspect ratio 2.26 between plate width and hole diameter, showing the most highly stressed locations as marked by red. Stress scales are as per the applied loading and only their relative magnitudes are important.

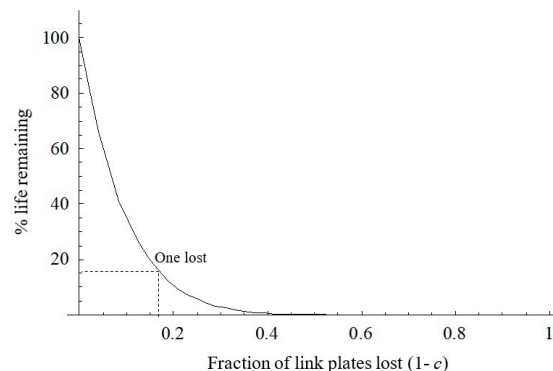
For steels which are the usual chain materials, the average value of  $a$  is known to be around 0.1 (Roessle and Fatemi, 2000; Smallman and Ngan, 2014). Thus, taking  $a$  to be this value, the residual life given in percentages predicted by Equation (5) are shown in Figure 6. After the first link plate is lost prematurely compared to others, the residual life is predicted to be reduced to only about 16% of the original; for example, a year would be reduced to two months, six months would be reduced to one month, and so on.

It should be noted that the reduction of residual life to 16% predicted from Figure 6 is actually an upper limit, and the actual residual life should be much lower for the following reasons:

Therefore, after the first link-plate is lost, an original one year of residual life may well be reduced to a few weeks. In fact, it could even be possible that only a few days of the residual life remain. At the end of this residual life, the second link plate would fail by fatigue, and then

Figure 6. Residual life of drive chain after loss of one or more link plates, predicted by Basquin's Law model with fatigue strength limit  $a = 0.1$ .

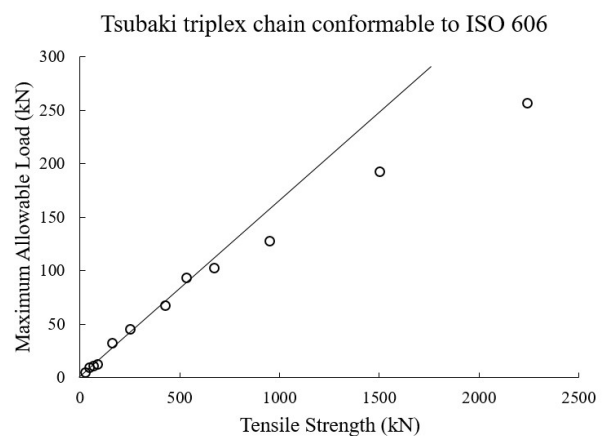
1997), and both the tensile strength ratings as well as the maximum allowable loads are specified in their products (Figure 7). As this manufacturer’s chains are compatible with, and actually exceeding, ISO 606 requirements, fatigue may still be avoided at safety factors lower than 8 or so. From the data in Figure 7 for their triplex chains, it can be seen that for tensile-strength rating up to about 500 kN, the maximum allowable strength for avoiding fatigue is about 1/6 of the tensile strength rating. Furthermore, it is stipulated that the design load should be set lower than the maximum allowable load by at least 10%. Therefore, to avoid metal fatigue, the safety factor has to be at least 6.6, for the type of Tsubaki chains described (U.S. Tsubaki, Inc., 1997).

Figure 7. Relation between maximum allowable load (dynamic strength) and tensile strength rating in ISO 606, for triplex chains supplied by a chain manufacturer Tsubaki (U.S. Tsubaki, Inc., 1997). Straight line shows a ratio of 1:6.
