# AI-powered inspections of facades in reinforced concrete buildings

Michele De Filippo<sup>1</sup>, Sasan Asadiabadi<sup>1</sup>, J S Kuang<sup>2</sup>, Dhanada K Mishra<sup>1</sup> and Harris Sun<sup>1</sup>

<sup>1</sup> RaSpect Intelligence Inspection Limited, Hong Kong, People's Republic of China

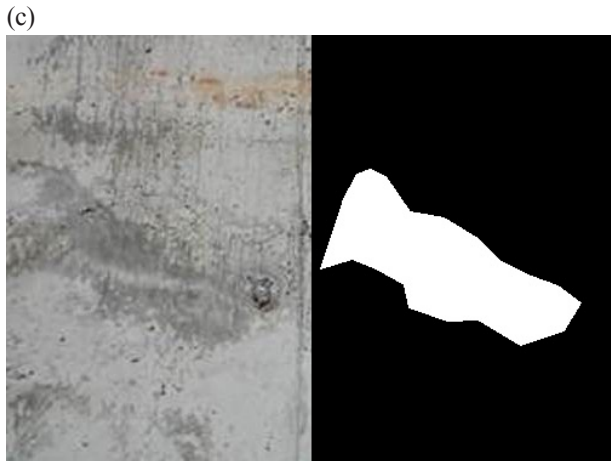
Figure 4. Data labelling for the micro inspection of (a) cracks; (b) delamination; and (c) stains.

The 722 crack images, 532 delamination images and 513 stain images made up the initial training database. Since the randomly posted images on the web are not well tagged with the flaw area, and the shape of the defect region tends to be stochastic in distribution, it is necessary for areas to be manually labelled as shown in Figure 4.

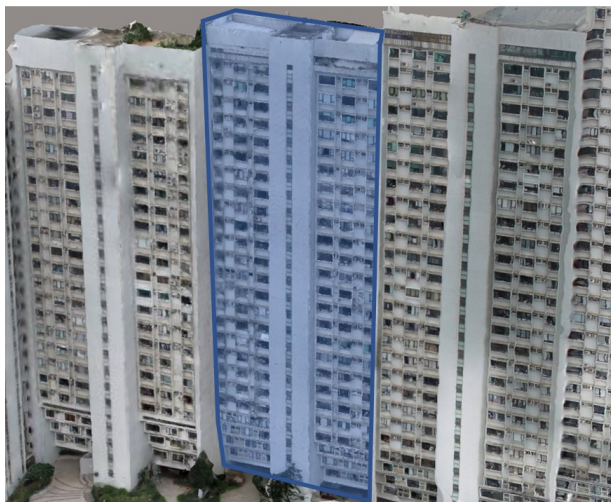
Figure 13. (a) Inspected site; and (b) summary of the inspection results.

units with areas ranging from 434 to 2,000 square feet. The inspected 25-storey facade has a surface area of  $27 \times 65 \text{ m}^2$ , as displayed in Figure 13(a). The survey flight took place on one single day using four batteries taking visual and thermal photographs. The flight time was 300 minutes, and 1,000+ photographs were captured. The facade was inspected using a Matrice 210RTK (DJI, no date-a) with an X5S visual camera (DJI, no date-b) paired to an XT2 thermal camera (DJI, no date-c). The inspection was conducted using a pre-programmed flight path designed using the Litchi App v2.5.0 (Flylitchi, 2020). The operation crew was composed of one pilot-in-command and one observer/spotter. Since the building is located in a densely populated area, the pilots experienced problems in terms of poor signal reception. Accordingly, the flight path depicted in Figure 2 was adopted with two pre-planned take-off points, from the bottom and top of the building, respectively. The image processing through the described analytics and endorsement of results by a certified professional took four days. The detected defects are labelled under four major categories of inspection outcomes including: cracks, delamination, stains (detected in visual data) and thermal anomalies (detected based on thermal data). The defects are displayed in Figure 13(b). The collected images contain GIS metadata including longitude, latitude and altitude. Such metadata along with the collected images are used for projecting the defects onto the facade. As a result, images are spatially allocated to different portions of the building. All the recognised defects and anomalies are mapped at their location and a comprehensive understanding and evaluation of the status of the facade can be achieved.
