## TECHNICAL NOTE

# Are super-long escalators safe? Lessons learned from the Langham Place escalator incident in Hong Kong

A H W Ngan and K W Siu

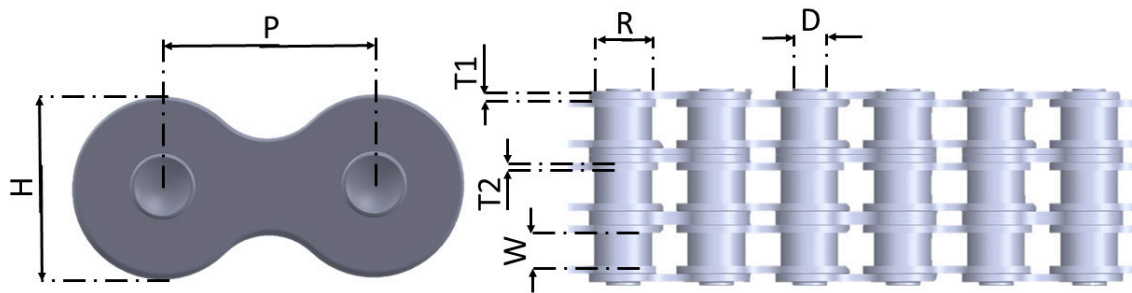
Figure 4. Geometrical specifications of ISO R606 24B-3 chains (FB Chain).

As shown in Figure 2(a), the main drive chain transmits power from the motor to the movable steps of the escalator. As such, the drive chain is subjected to a predesigned tension during one half of its revolution, and is relaxed during the other half. Due to this form of cyclic loading, the drive chain is prone to metal fatigue. As illustrated in Figure 2(a), the drive chain design has a linked structure comprising link plates connected by pins and bushes. As indicated in Figure 2(b), fatigue cracks are preferentially initiated on the inner side of the link plates in contact with the pins or bushes (Figure 1(a)), where stress concentration is expected to be the highest. Figure 4 shows the geometrical specifications of the ISO R606 24B-3 chain used in the drive chain design of the Langham Place incident. The stress concentration factor in a plate containing a symmetrical hole is principally determined by the aspect ratio of the plate width (H in Figure 4) to the hole diameter (D in Figure 4), and is not significantly affected by the plate thickness T1 or T2 (Pilkey, 2005).

$$\frac{\text{Plate width}}{\text{Hole diameter}} = \frac{H}{D} = \frac{33.00}{14.62} = 2.26 .$$
